Rentokil
Property Care

Reference: CD/RK/CB
Enquiry No:0501/9C11143

<p><u>Property Address</u> The Abbey Church High Street Dunbar EH42 1EN</p>

THE SURVEY

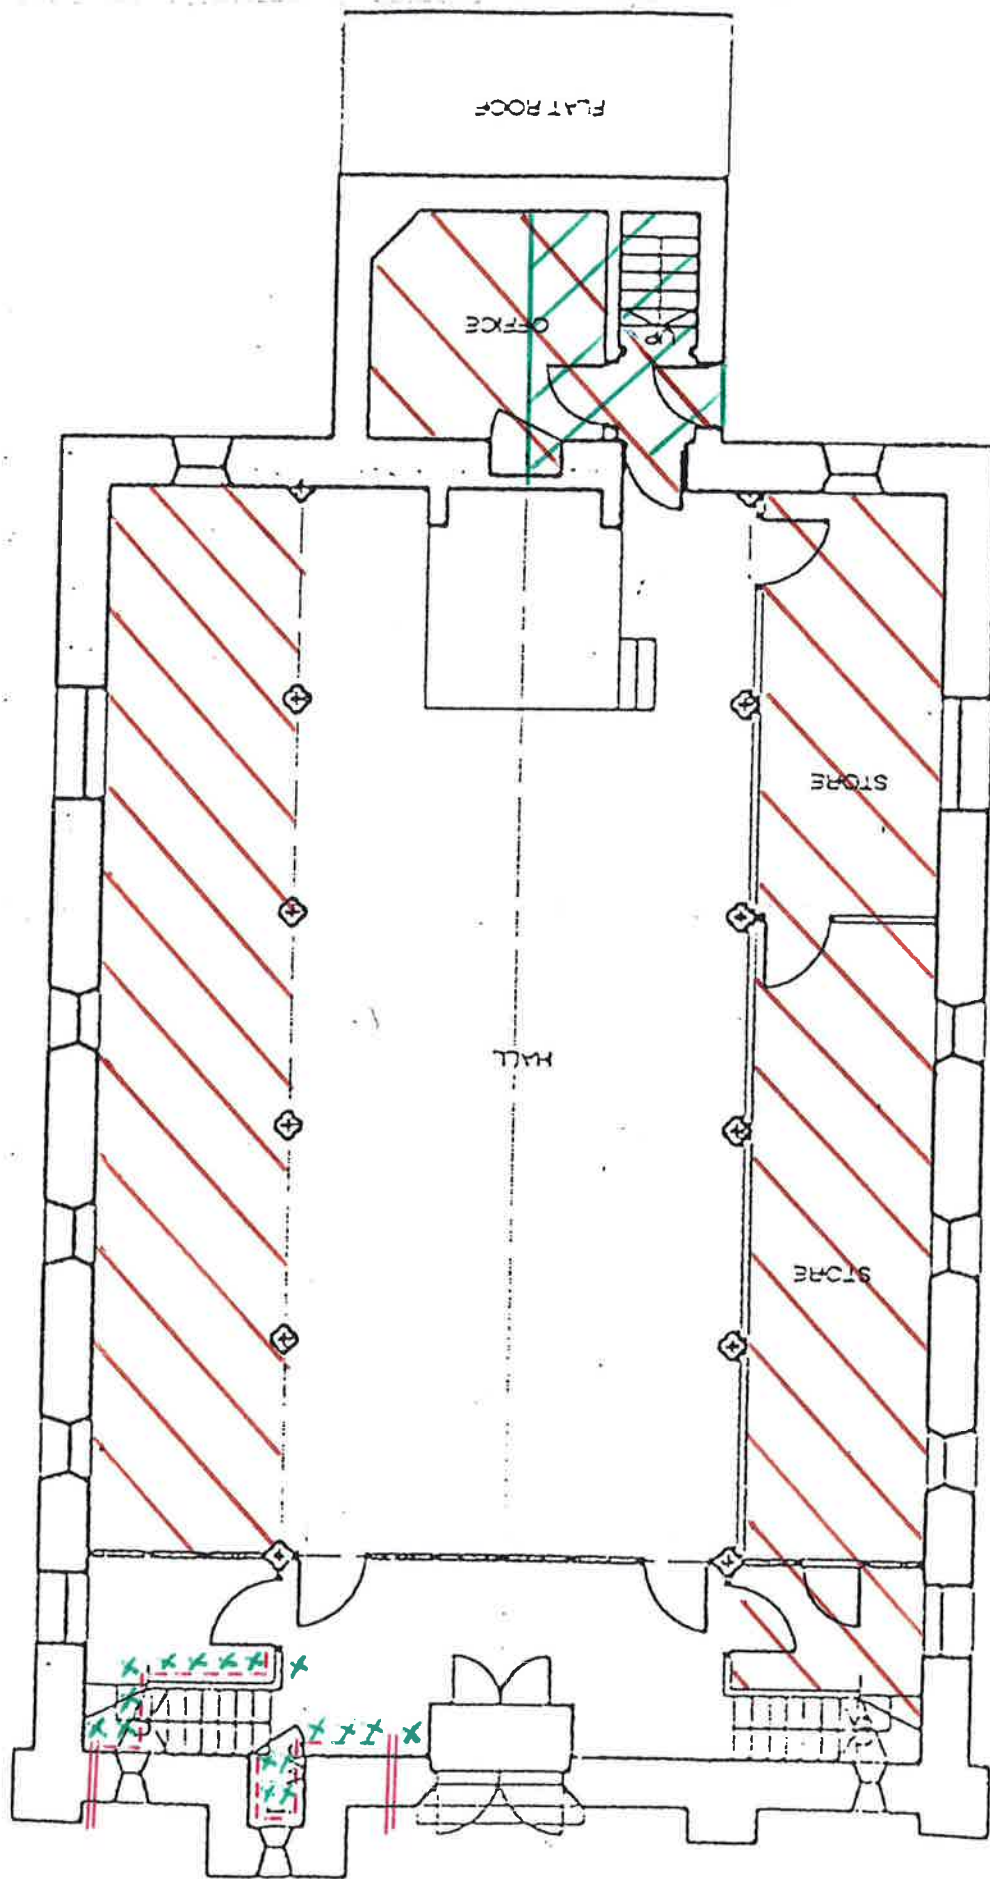
- /// Remove flooring + joists
- /// Rafters + Sarking to be removed
- - // Damp proof course
- x x Tanking

== Support Beams
to be removed

| Flat roof joists

to be removed

- (1) Brush down all walls.
- (2) Apply Control Fluid SB to the exposed wall masonry.
- (3) Install the Rentokil horizontal damp proofing system in the area of the walls marked on the attached sketch plan.
- (4) Form vertical isolations.
- (5) Form wall floor joint.
- (6) Apply the Rentokil wall-tanking system to the walls marked on the attached sketch plan.
- (7) Leave ready for others.

- (1) Remove flooring, joists and wallplates as shown on sketch and dispose.
- (2) Brush down all walls.
- (3) Clear all debris from the exposed solum.
- (4) Replace the wall plate and protect it with a damp proof membrane, as necessary.
- (5) Supply and fit new pretreated joists from the external wallheads back to dwarf wall protecting the wall being ends with Control Paste SB and a damp proof membrane.
- (6) Drill and inject base of supporting columns with Control Fluid SB.
- (7) Apply Control Fluid SB to the remaining sub floor timbers.
- (8) Lay new pretreated 28mm tongue and groove flooring.
- (9) Leave ready for others.

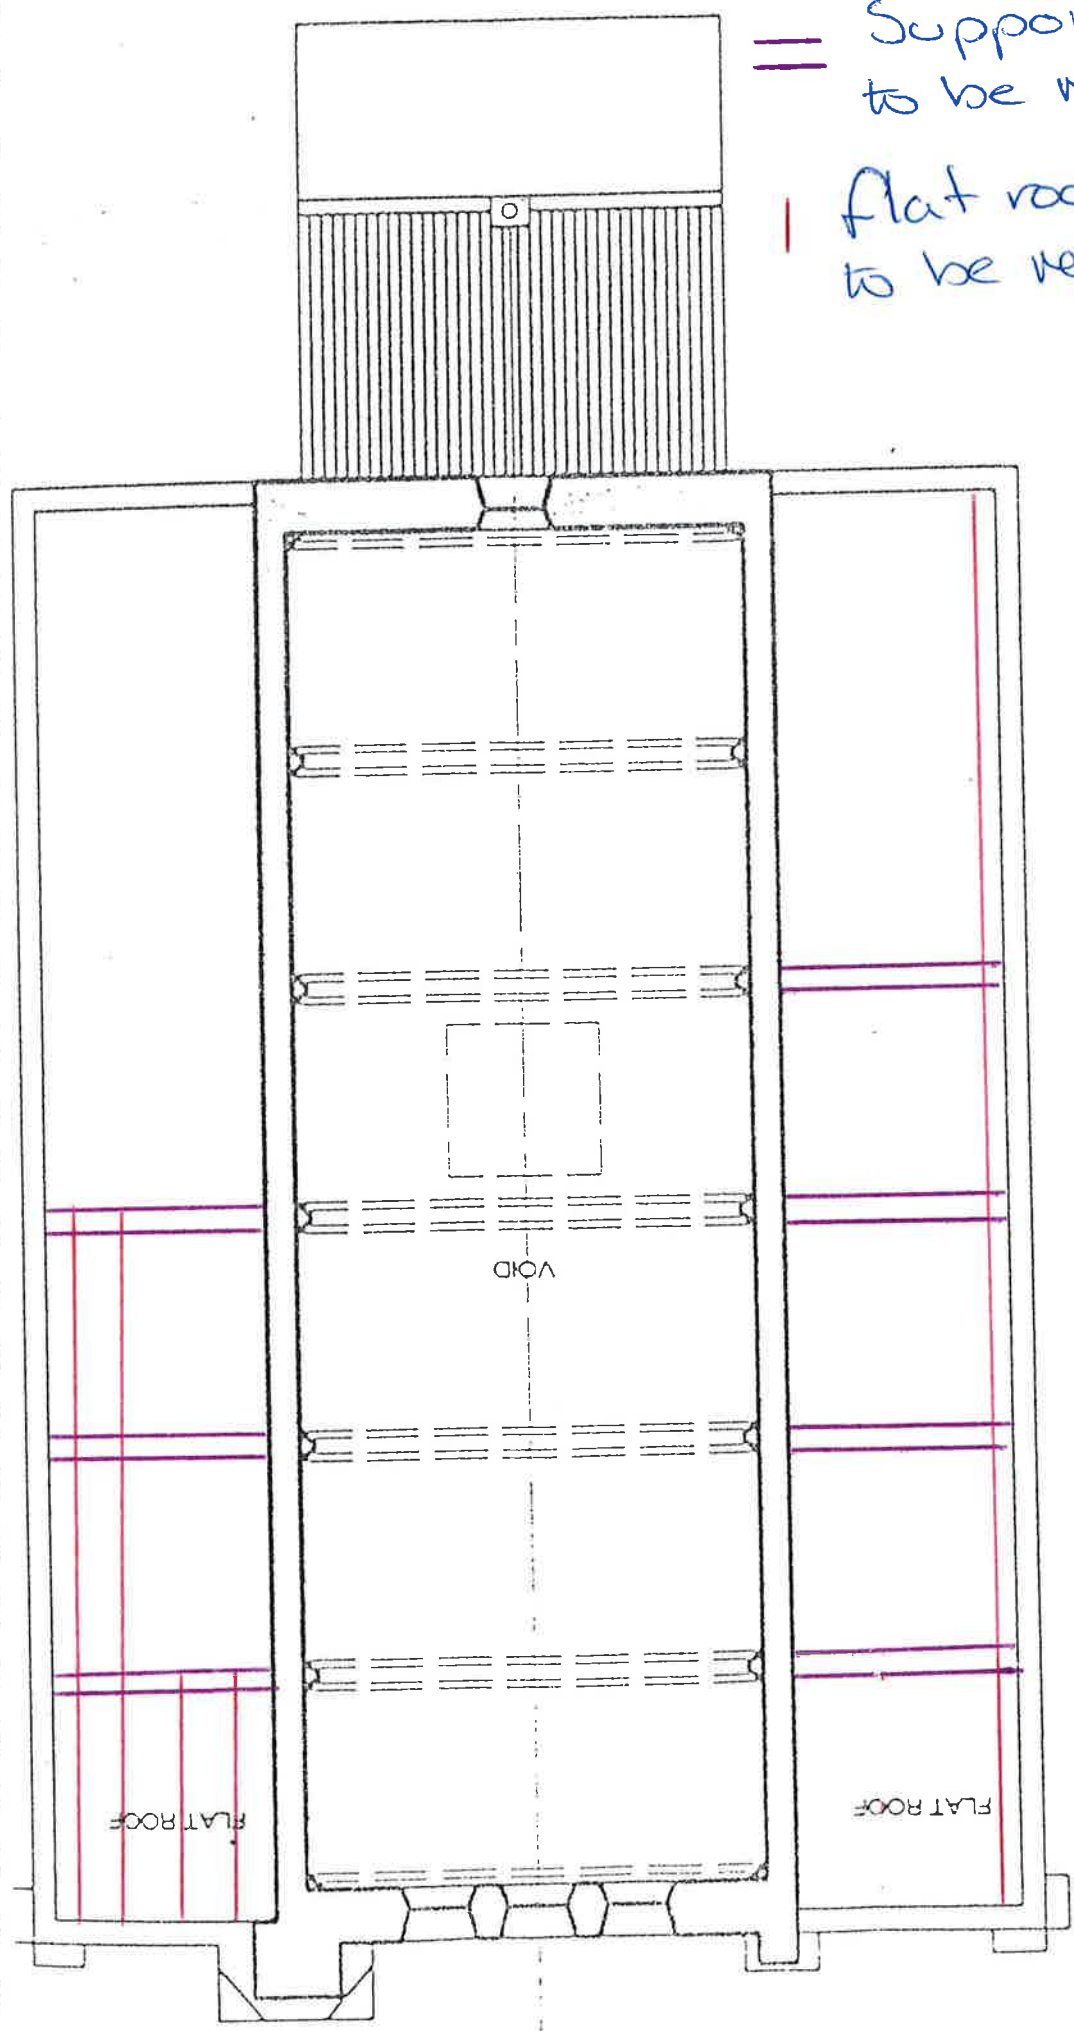
/// flooring + Joists
Removed

— Support Beams
to be removed

- (1) Remove floors and dispose.
- (2) Remove all exposed joists and dispose.

- (3) Remove main supporting beams from the central columns to the external walls as shown on sketch and dispose.
- (4) Apply Control Fluid SB to the exposed wall masonry.
- (5) Supply and fit new supporting beams protecting the wall bearing ends with Control Paste SB and a damp proof membrane.
- (6) Drill and inject remaining supporting beams.
- (7) Leave ready for others.
