Longnewton Farm, Longnewton, Haddington
Extended Phase 1 Habitat Survey & Physical Bat Survey

For Mr and Mrs Whiteford

04th April 2018

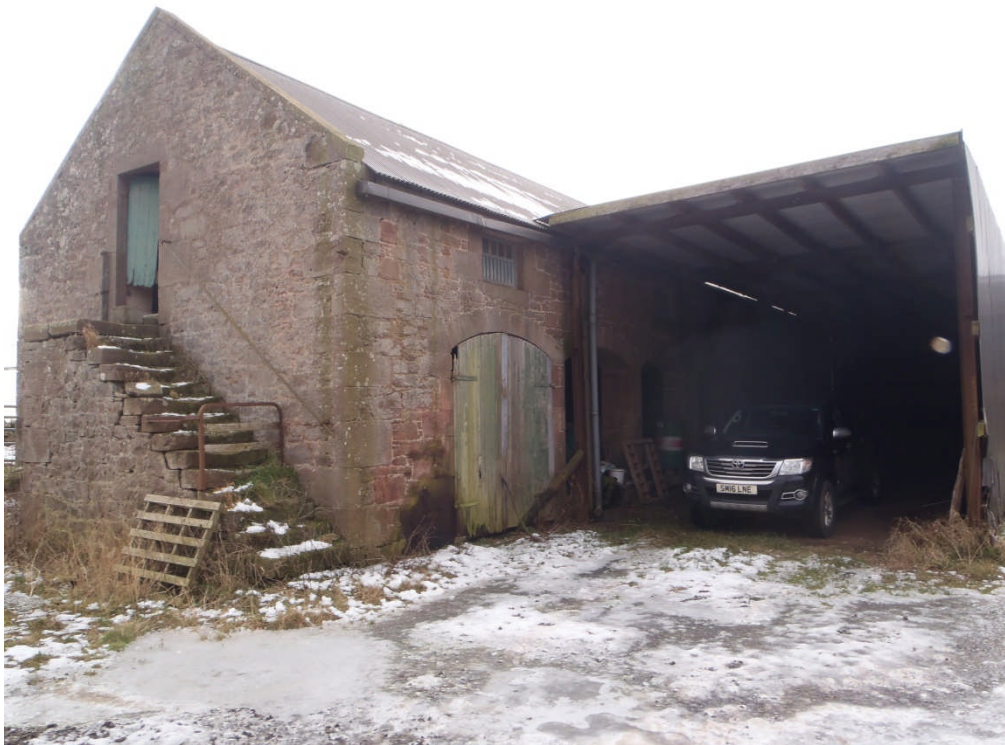
Picture 2: showing a view of building 1

Building 1 is located to the south of the site and comprises a sandstone block walls with a lean-to attached, open at the eastern end. The lean-to consists of a metal frame covered by corrugated metal sheeting and a flat corrugated metal roof. The sandstone building has a single layer corrugated metal roof. It has open archways in its northern wall, opening to the lean-to.

Four large silos, the full height of the building, are present on the south of the building. Unglazed window openings are present on the south of the building. The building is of two storeys, with wooden struts and beams and a wooden floor. The ground floor is used for storage of scrap timber, roofing and farm equipment. At the east end of the building is an external stone staircase leading to a doorway which would have served the upper storey. A partially destroyed door is present, allowing ingress of draughts and rainwater.

Numerous swallow *Hirundo rustica* nests and roosting feral pigeons were noted in the building.

The building was very draughty due to large areas fully open to the weather. The stonework was noted to be wet in areas, with patches of algae.

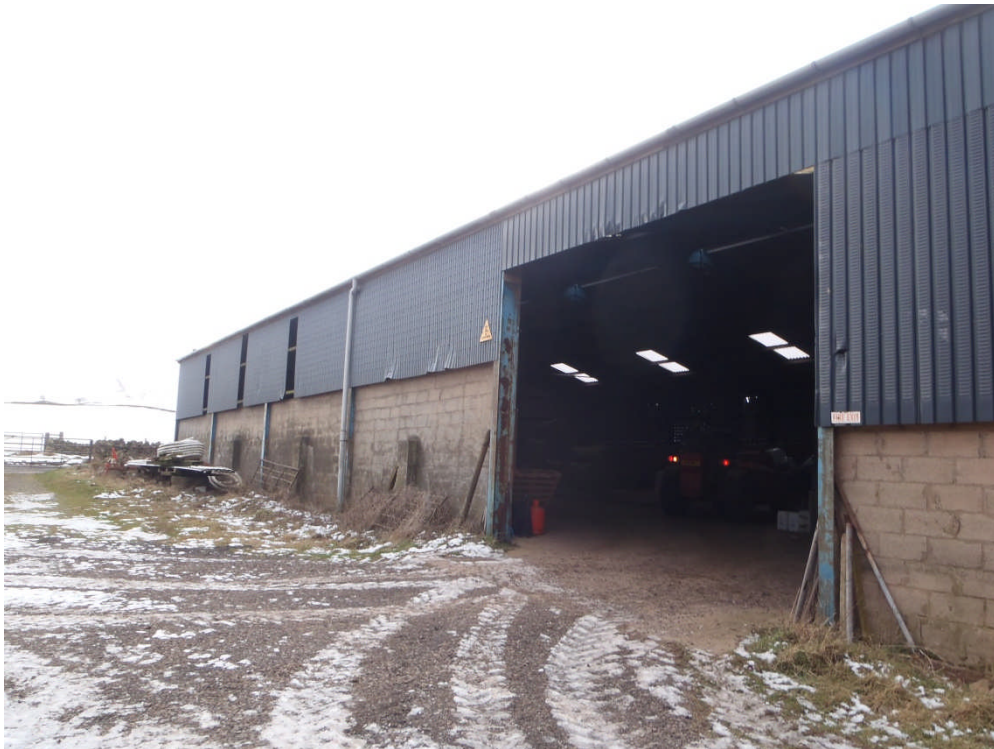
Picture 3: showing a view of building 2

Building 2 is a large metal-framed agricultural barn with a concrete floor. It consists of an approximately 2 metre breeze block wall topped by corrugated metal walls and a corrugated metal roof with Perspex windows. The barn has a large open doorway to allow vehicular access. It is being used to store agricultural vehicles, equipment and baled straw.

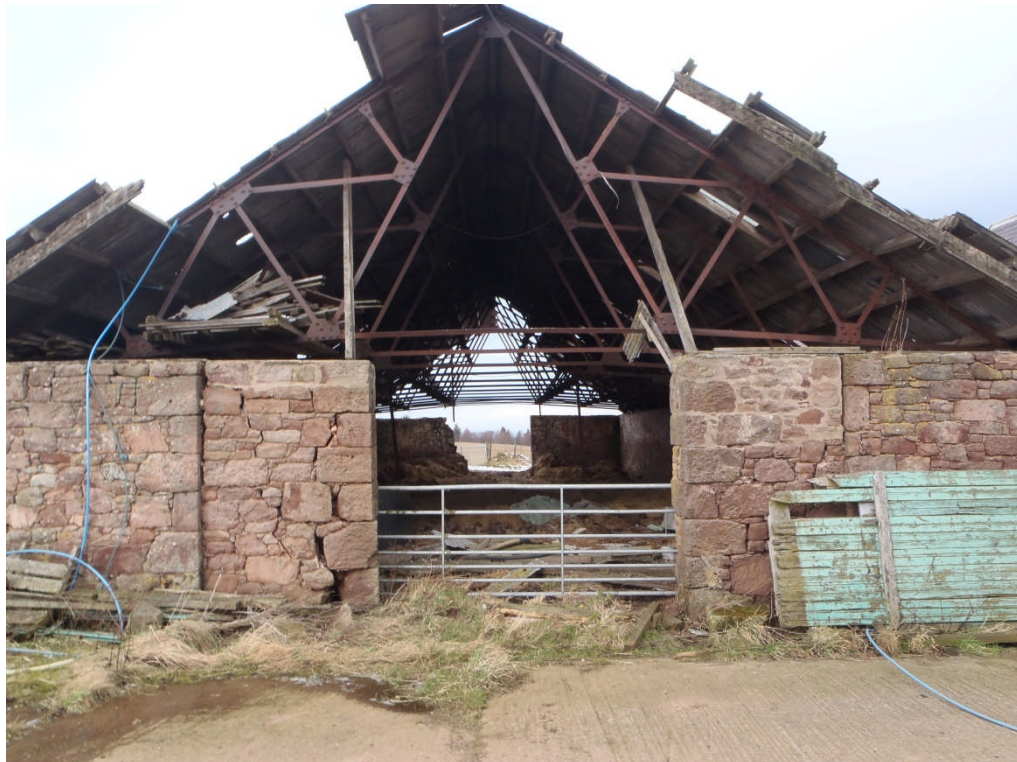
Picture 4: showing a view of building 3B

The western section (3B) is a largely collapsed agricultural barn. It is disused, and completely open to the weather. There is a metal frame and the remains of a stone wall base and some areas of corrugated metal roof, although the this is largely missing.

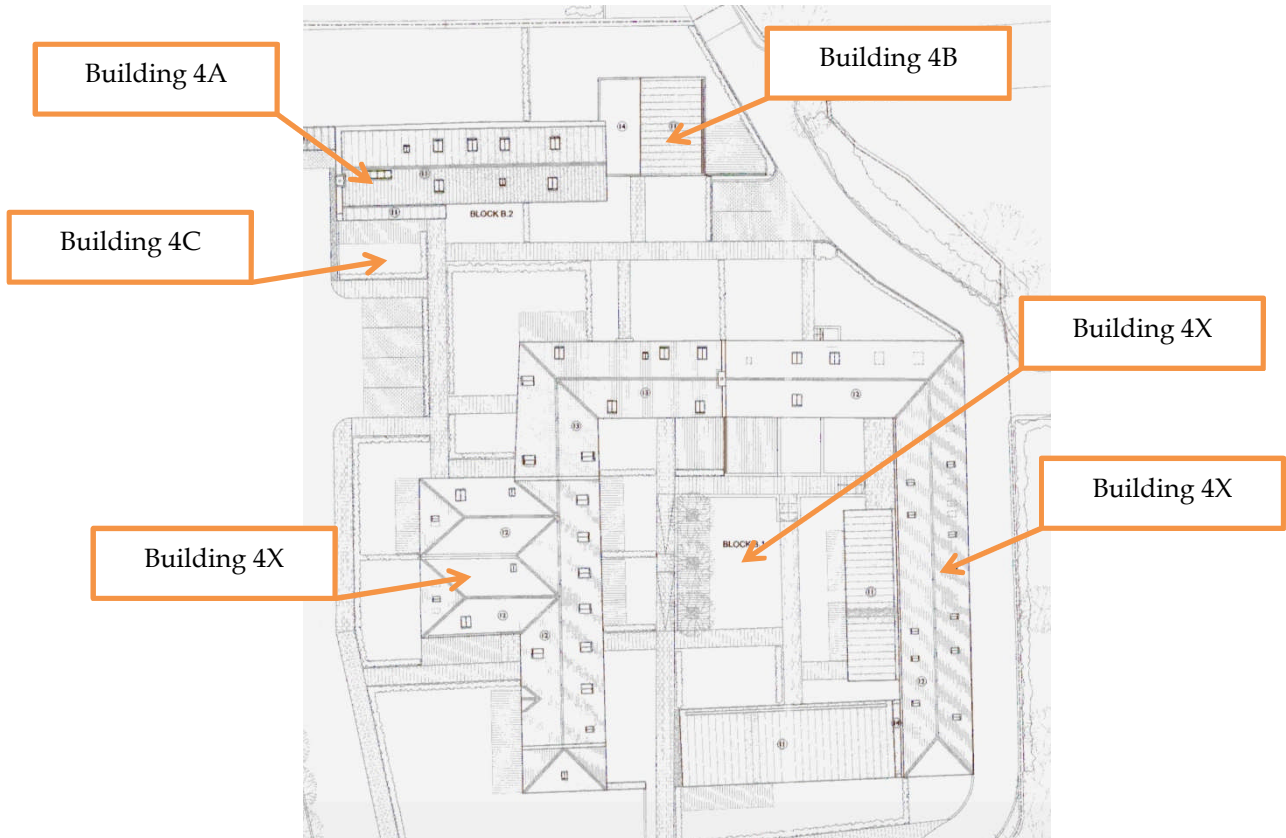
Figure 3: Building 4 plan

Building 4 is a complex of barns which has been split into seven areas for the purposes of this report.

A barn owl *Tyto alba* was noted to be roosting in building 4, with prey remains (feral and woodpigeon) and pellets present. A single owl was identified during the survey however no nest was found and the site is assessed as a perch.

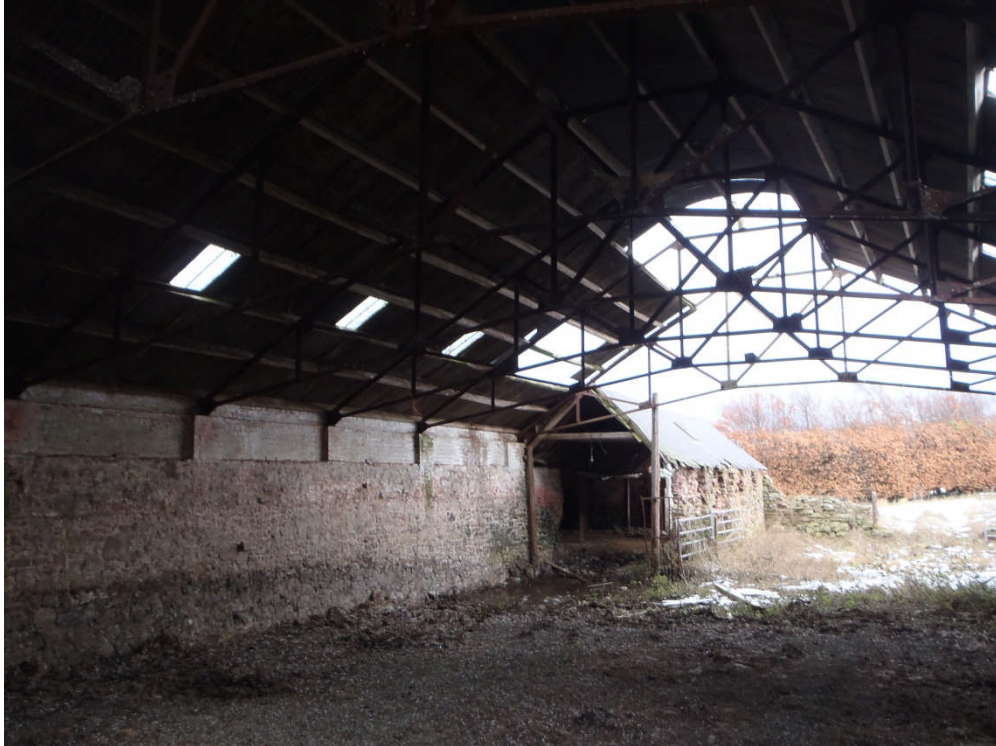
Picture 5: showing a view of building 4A and 4B

Section 4A is a barn with a sandstone wall of approximately 2 metres in height, then a pitched corrugated metal roof supported by a metal frame. On one side, the stone wall is topped with approximately 0.5 metres of brick wall. Much of the roof structure is missing and it was noted to be moving in the wind during the survey. The barn is fully open at its east and west ends, allowing the wind to blow through it.

Section 4B is a small barn attached to 4A at its west end. It is comprised of sandstone walls and a timber and slate roof both in poor condition. It is completely open at its east end, and the west end opens into section 4A.

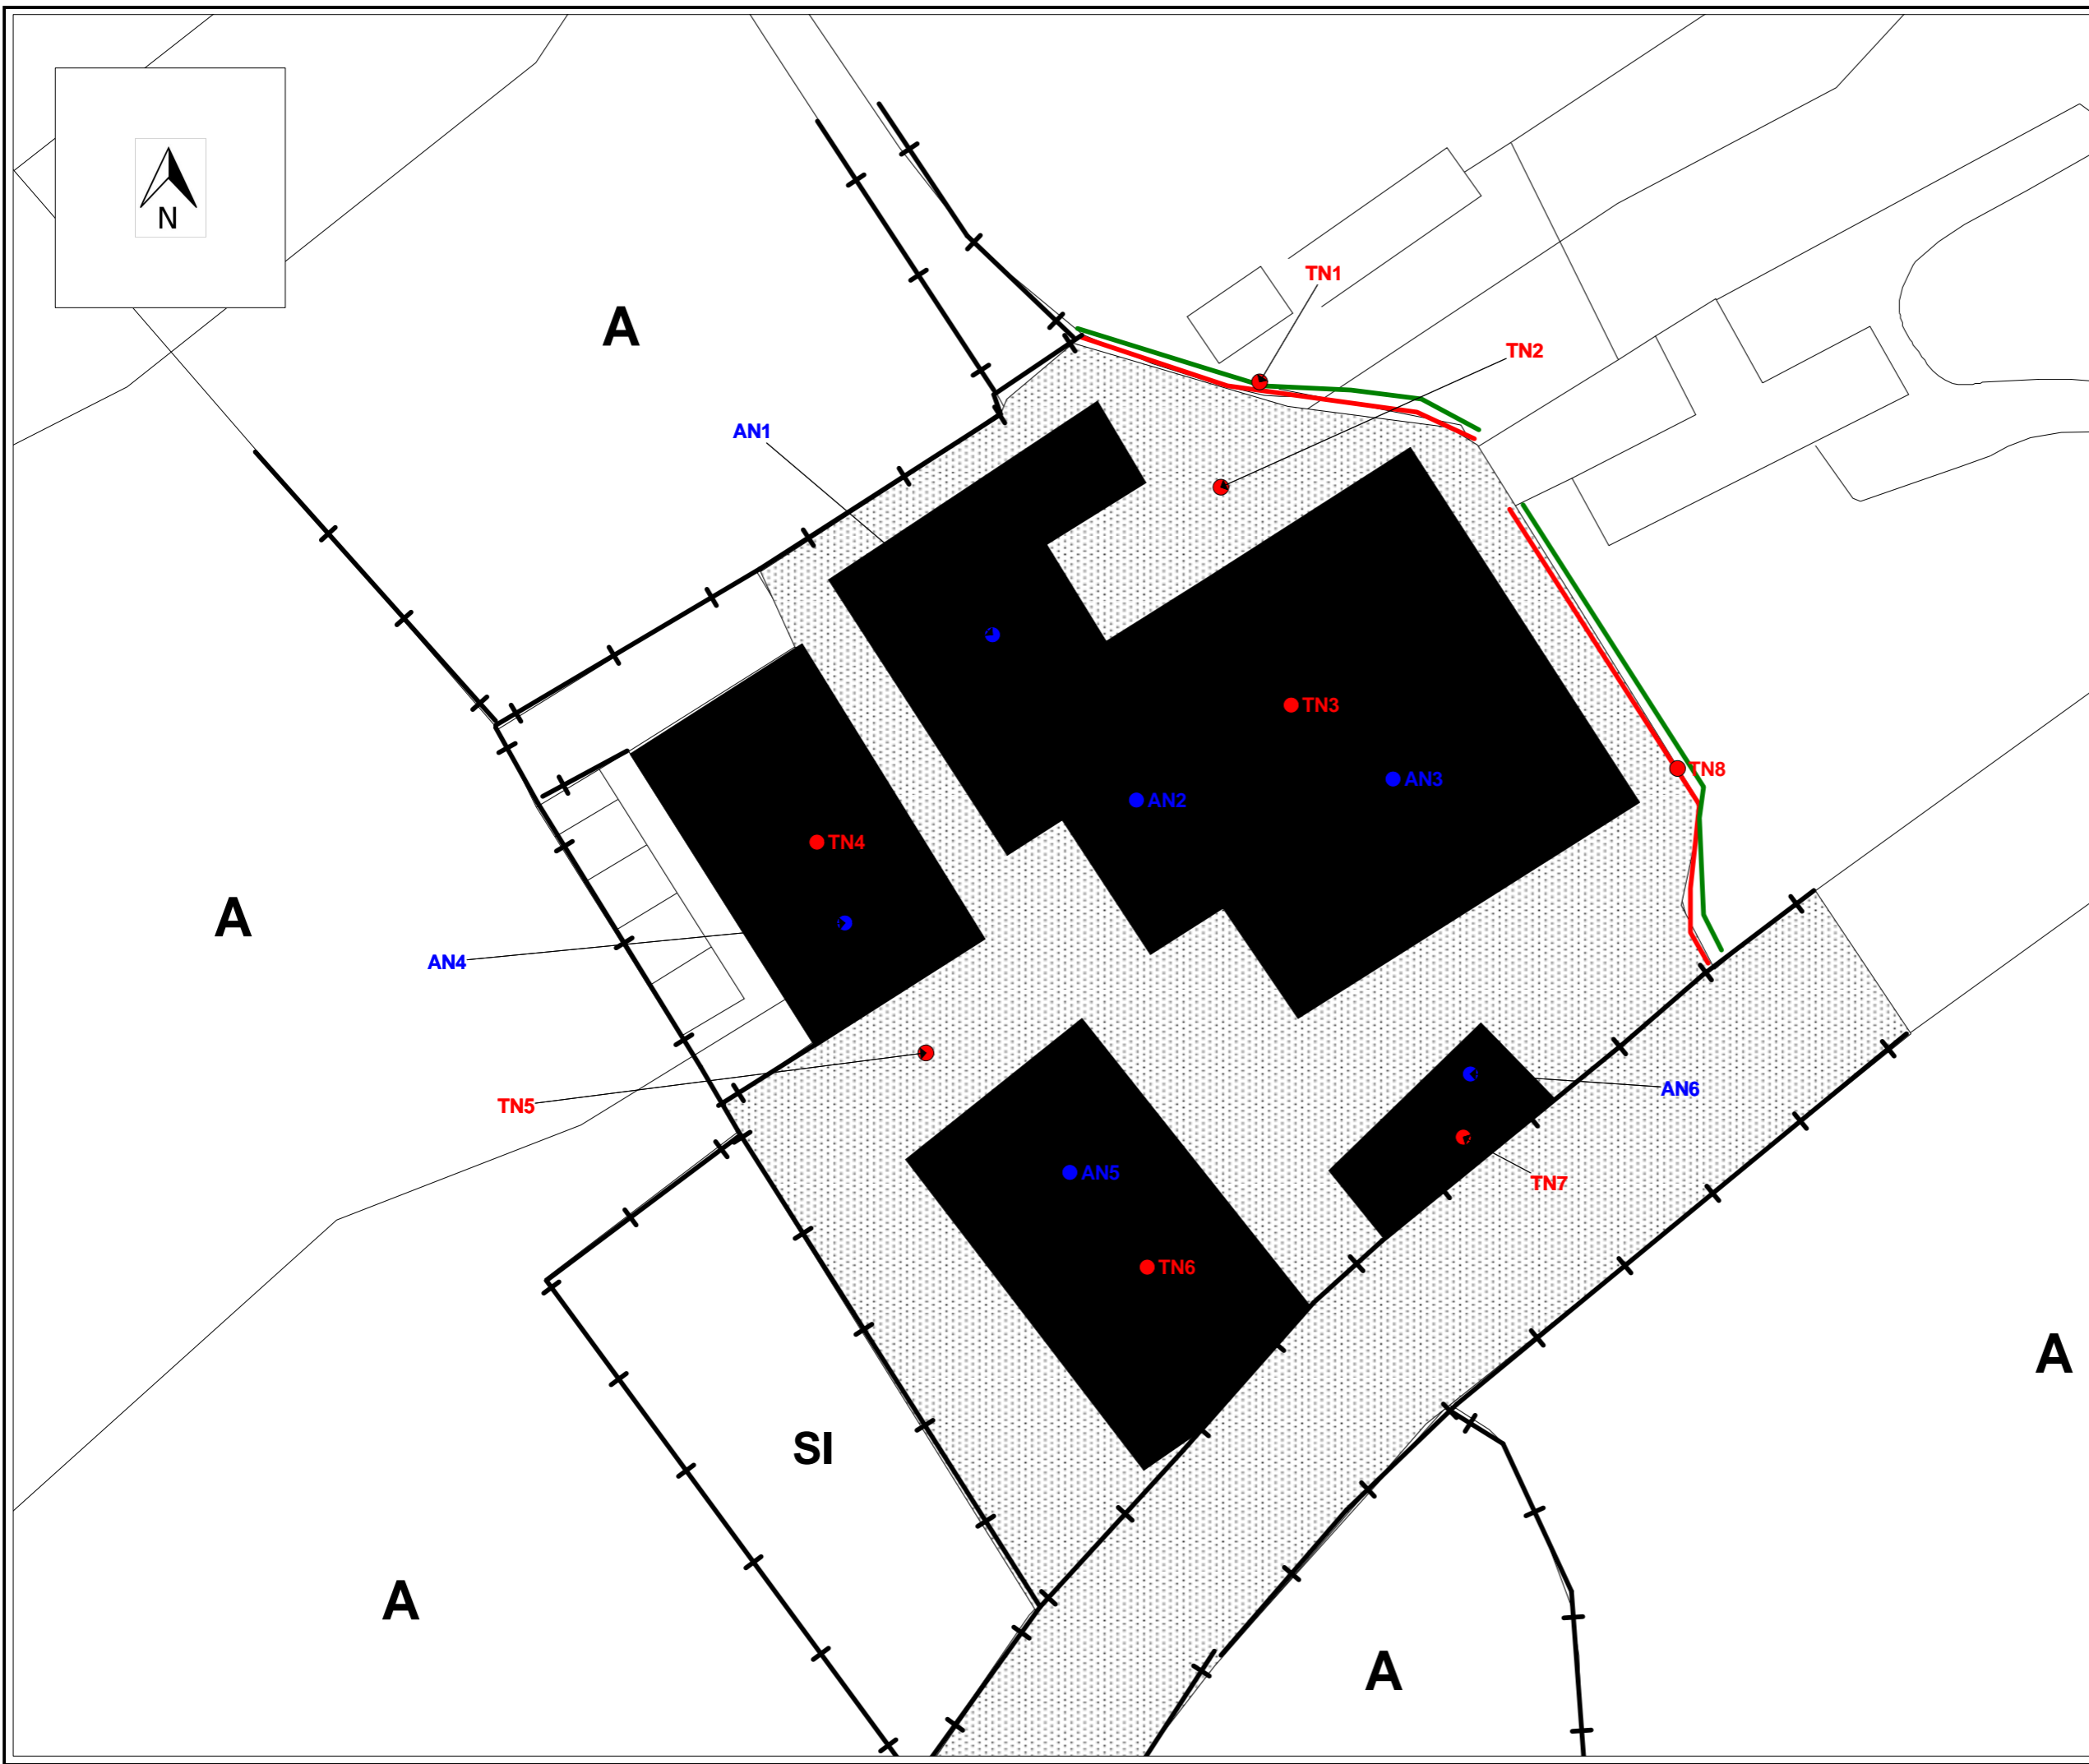
Drawing Title
Longnewton Farm
Extended Phase 1 Map

TN3 - Building 4 is a complex of buildings in poor condition.

TN4 - Building 3 comprises two barns in poor condition.

TN7 - Building 1 is a sandstone barn in poor condition.

AN2 - Evidence of barn owl found during the survey. No nest was found and the bird is thought to be roosting only.
