**Pressmennan Lake House, Stenton,  
EH42 1TF**

# CONSERVATION STATEMENT

Pressmannan Lake House & Grounds

WT Architecture

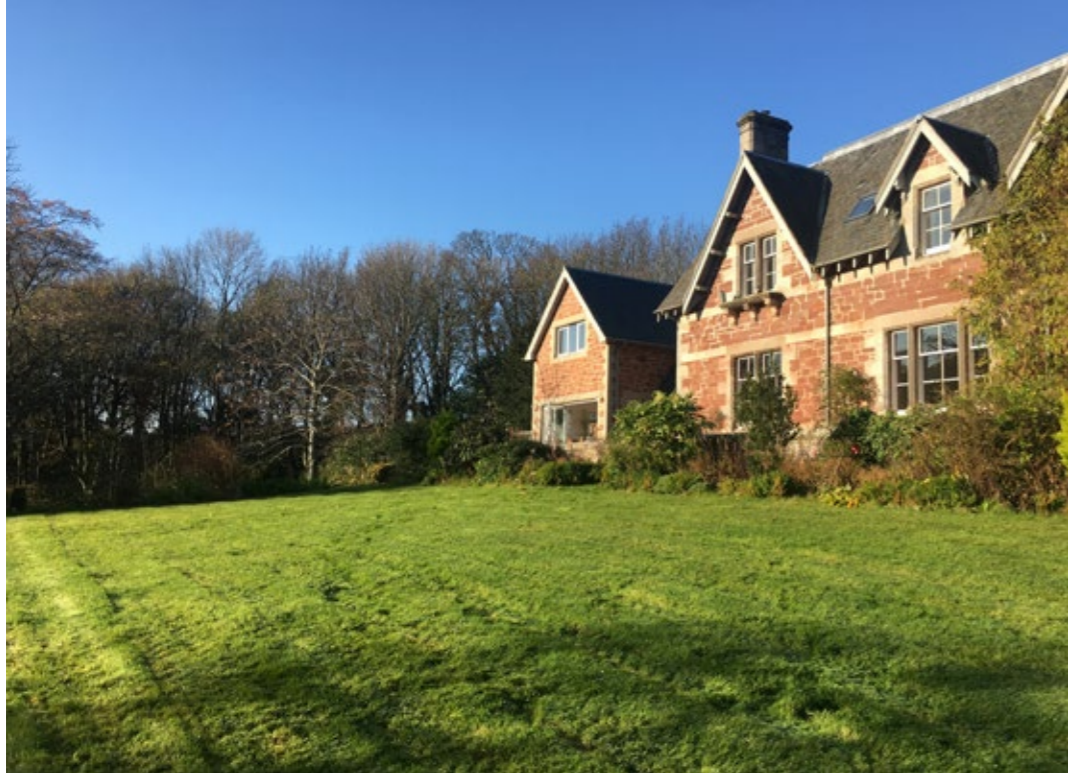
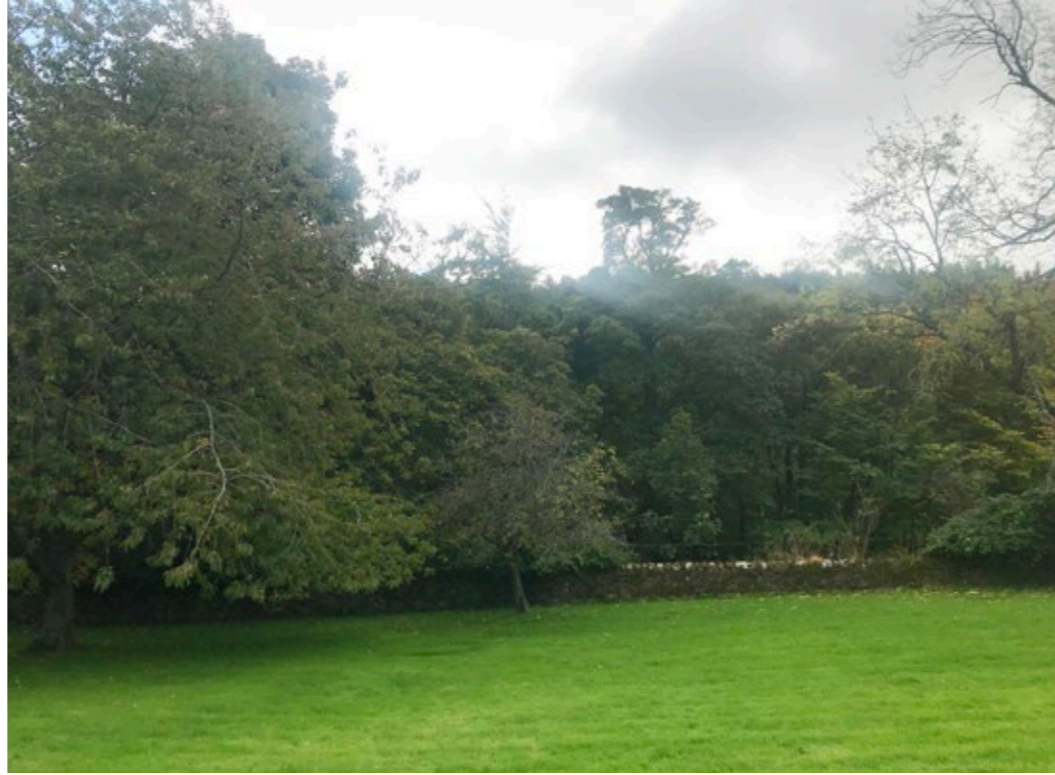
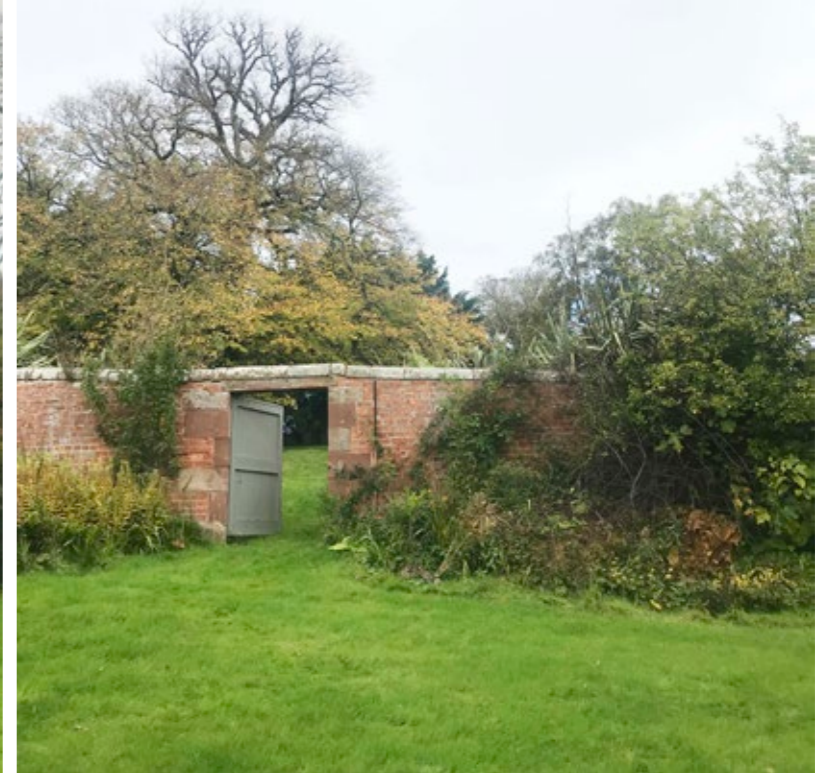
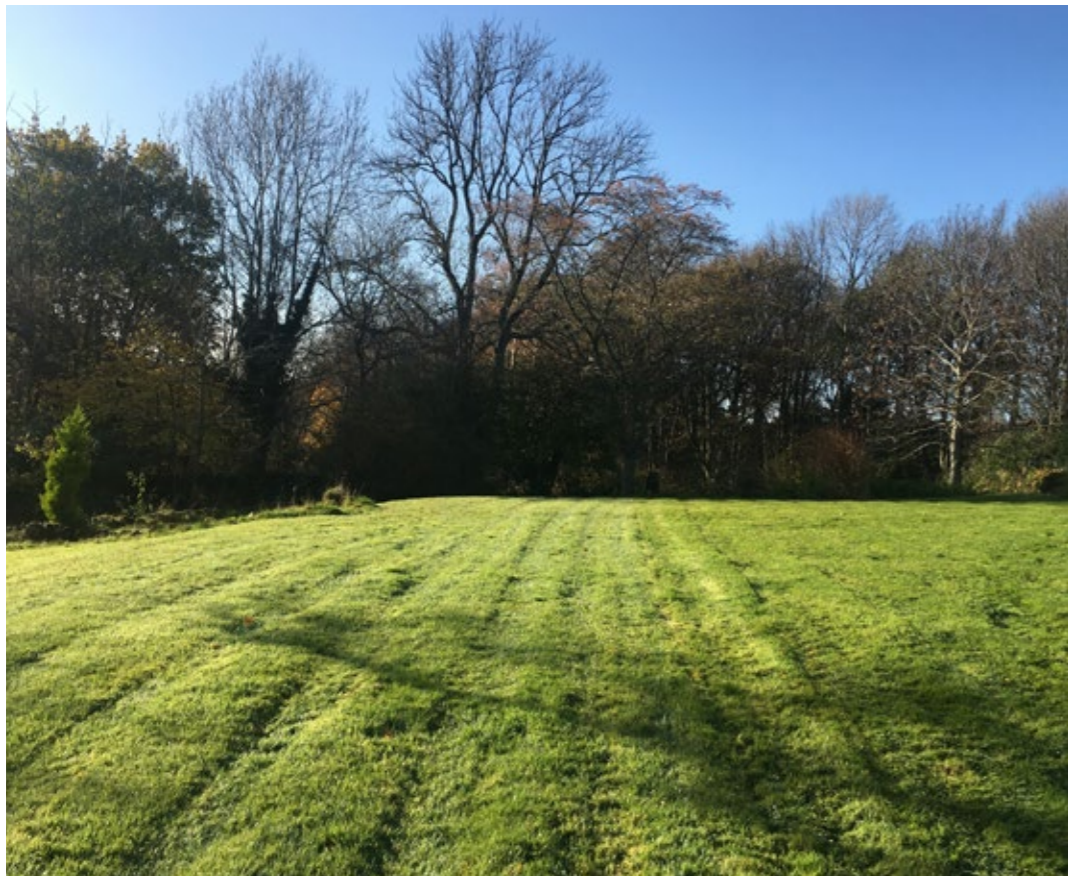
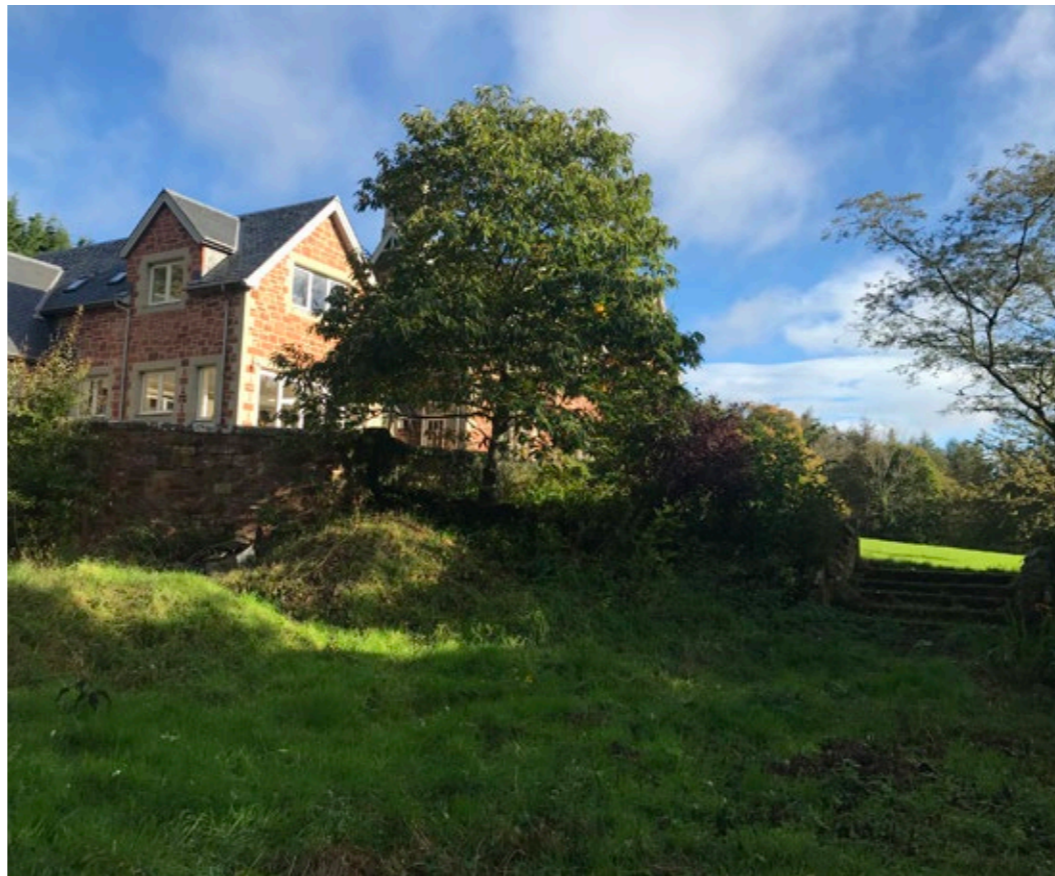
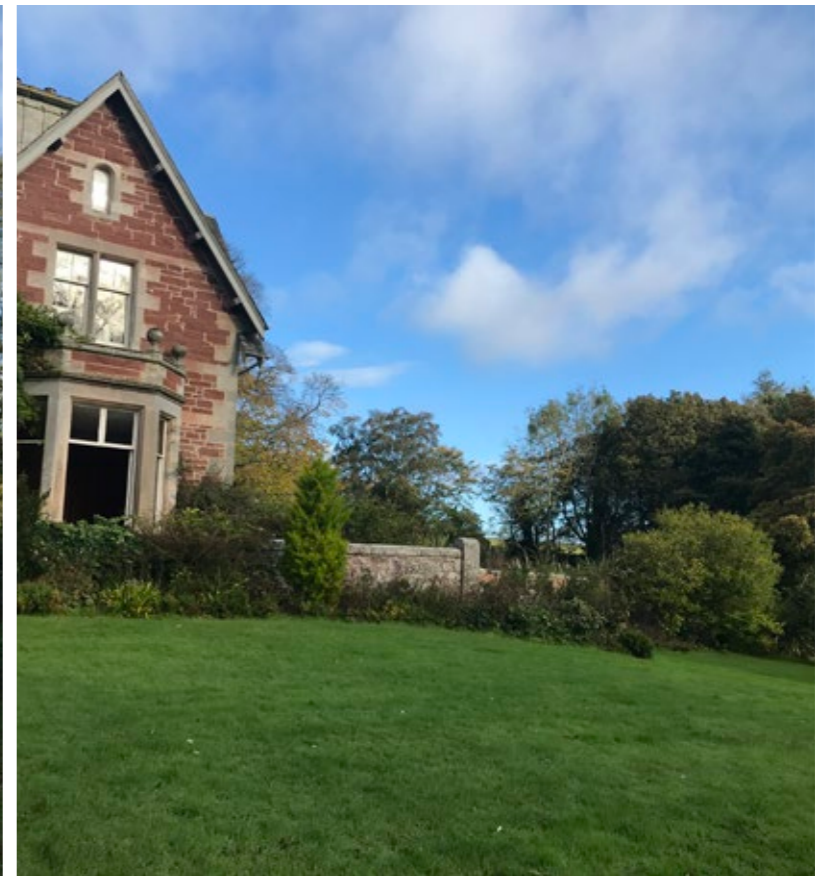
*Walled Garden*

*The lower walled enclosure of the garden where a series of ponds are located is in very poor condition, neglected and ostensibly derelict. The garden walls are intact to the east and south. Walls marked on 19th century maps around the SE lawn have now tumbled down. The north site boundary wall is in poor condition and will need to be repaired and repointed.*

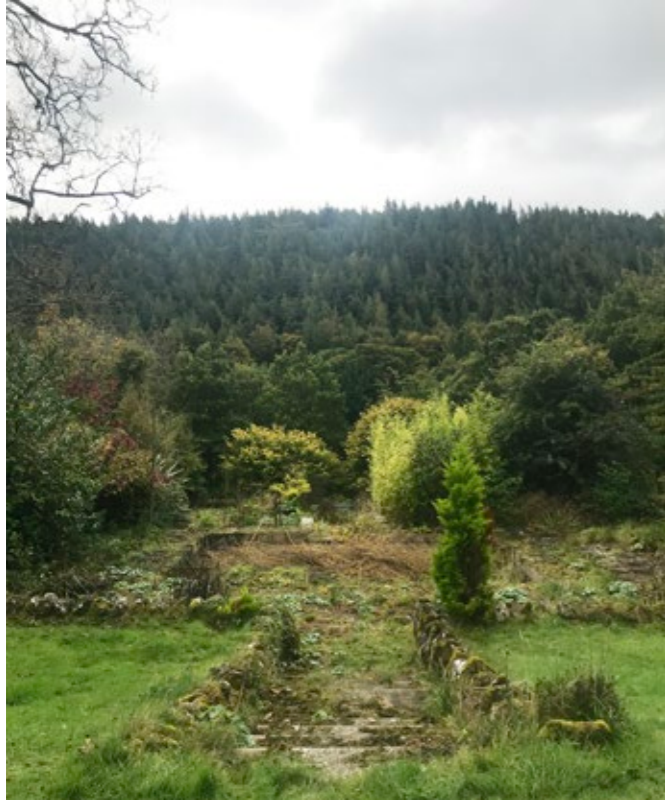
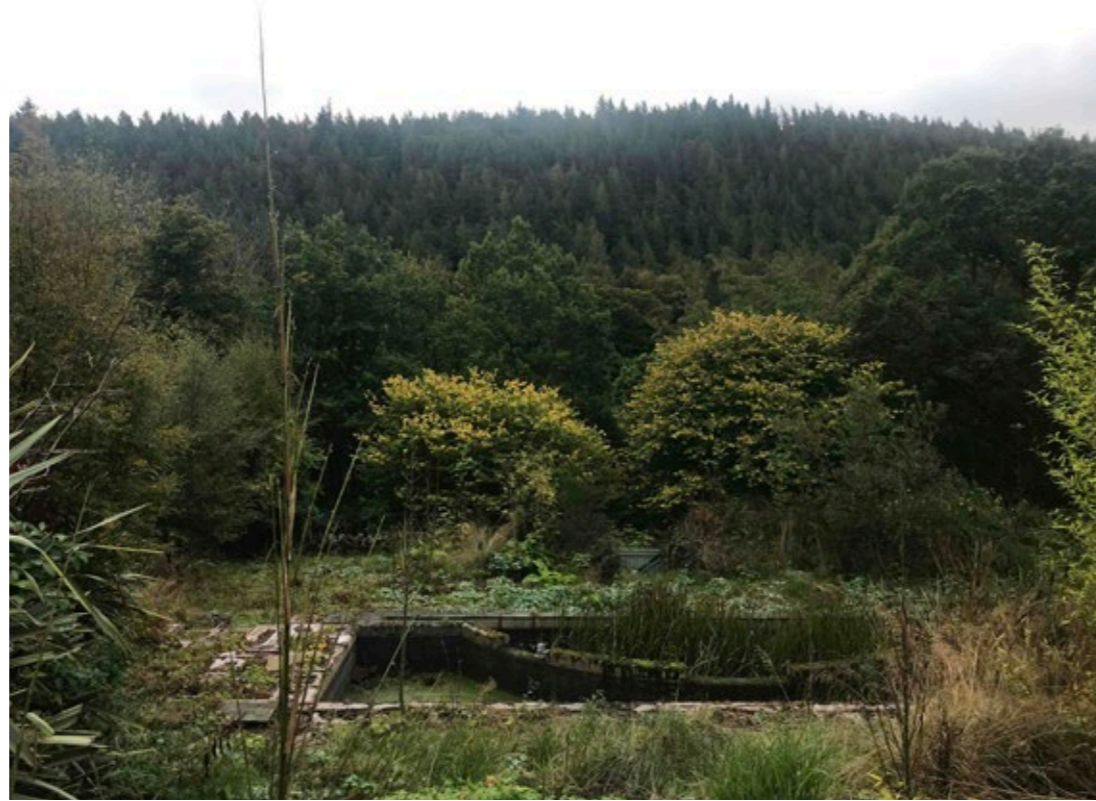
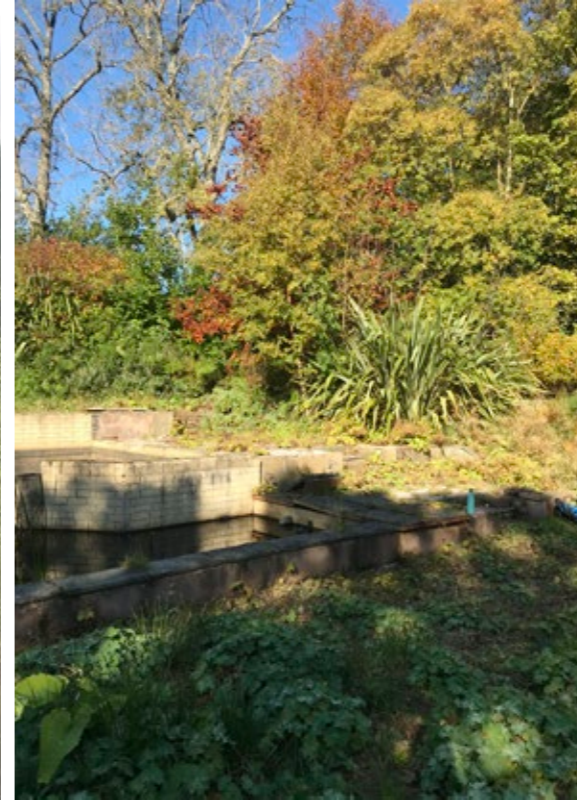
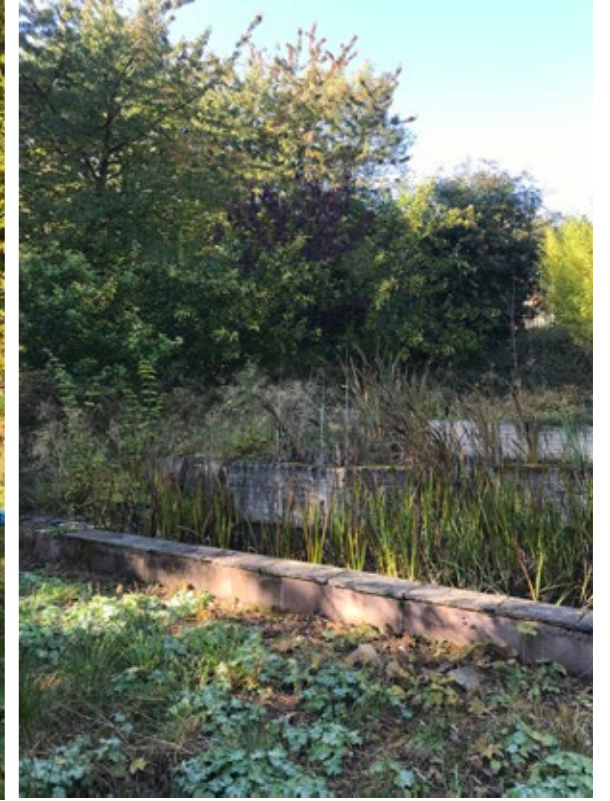
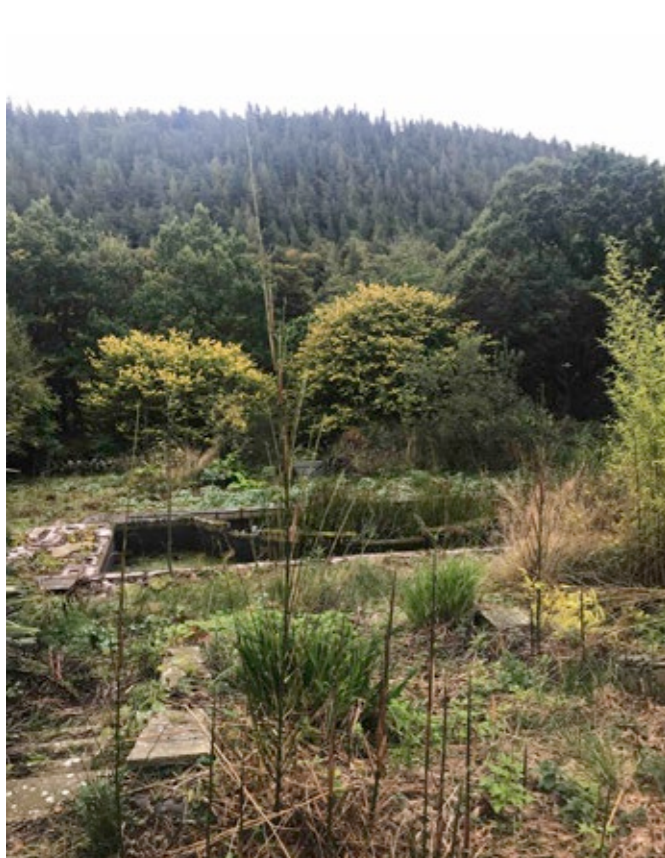
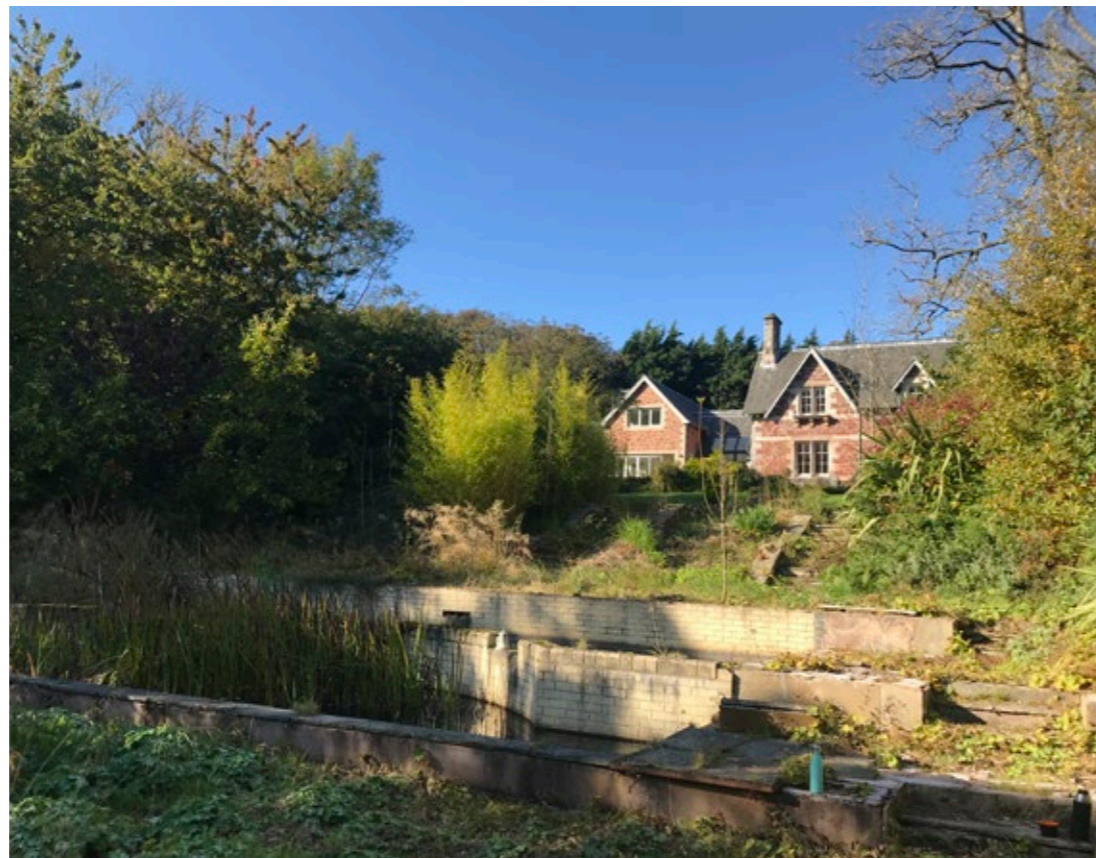
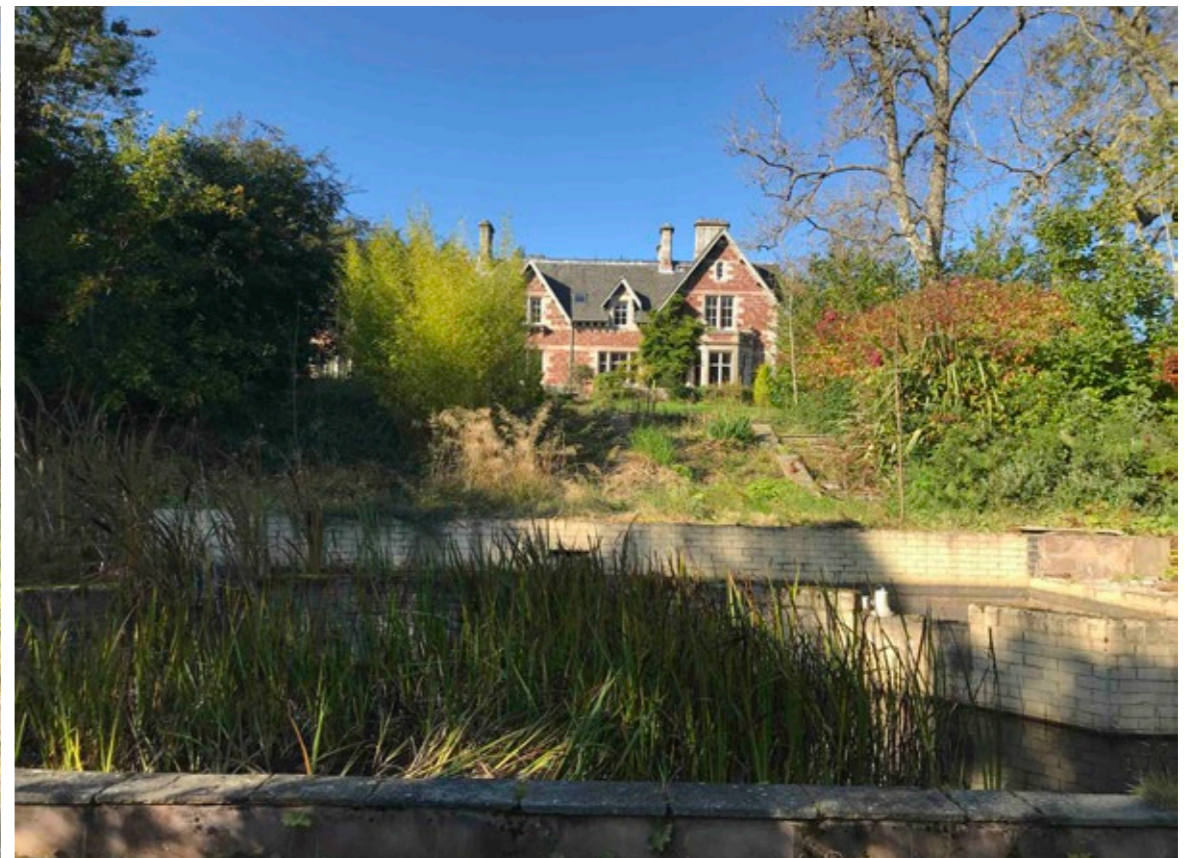
Derelict Ponds

Maps indicate that the southern-most enclosure may have been an orchard in the nineteenth century. In the late 1900's this area was extensively re-landscaped to create a series of concrete-brick edged ponds and water chutes. These ponds and surrounding pathways are now derelict and not holding water.

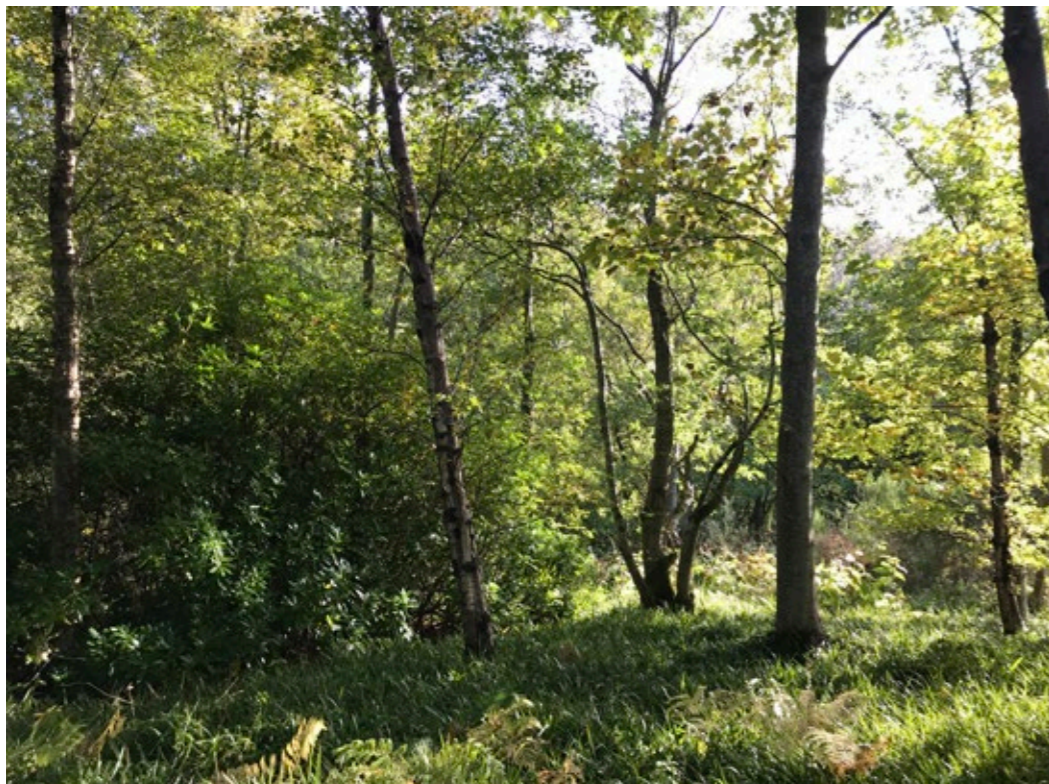
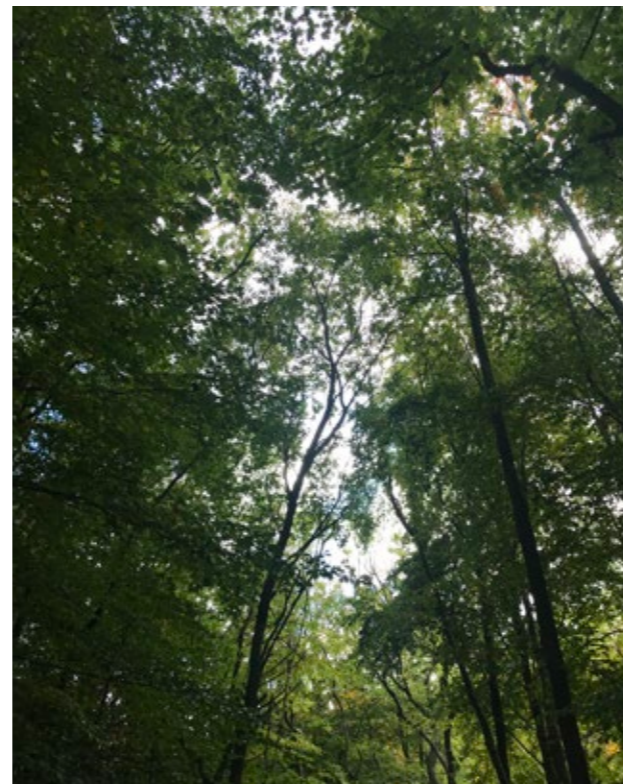
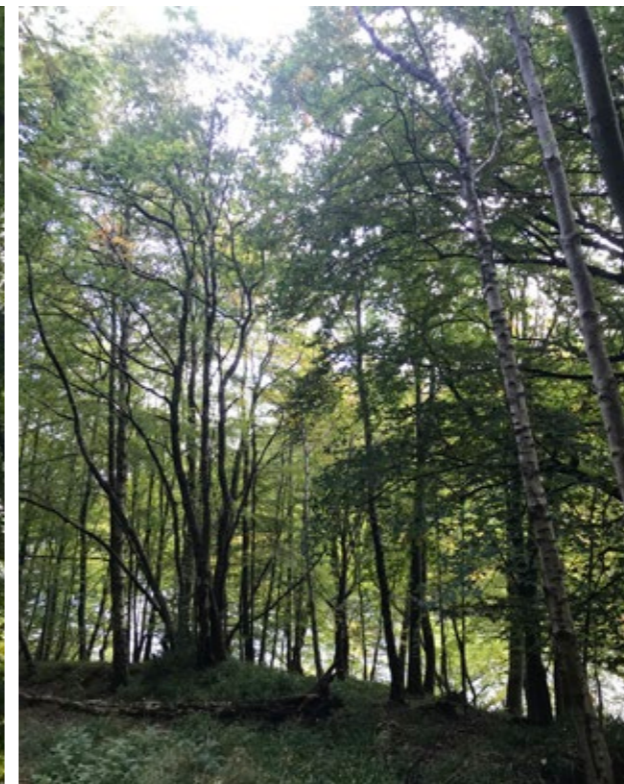
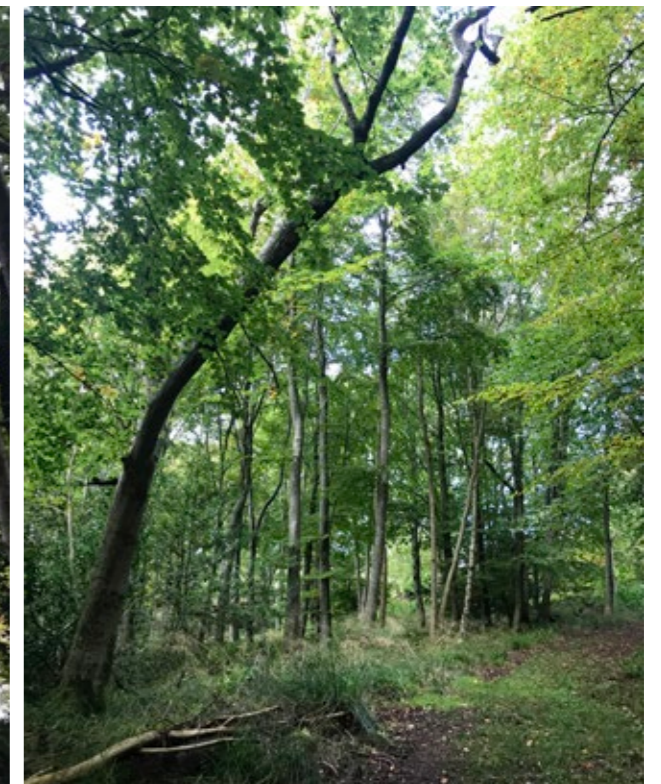
*Woodland Garden*

*The enclosed woodland to the south of the house that leads down to the lake is in need of some woodland management, with dead and weak trees attended to, and localised thinning. The upper pathway that follows the contour here is in need of clearance and maintenance. The track to the boathouse is also in need of clearance and maintenance. The boathouse itself is structurally sound but in need of some roofing maintenance.*
