CLIENT Mr & Mrs Lambie
 3A Dirleton Avenue
 North Berwick
 POSTCODE EH39 4AX
 TELEPHONE 01324623283

PROJECT SPECIFICATION
 Proposed Replacement Windows

CONTRACT No 26661401 DRAWING No 001

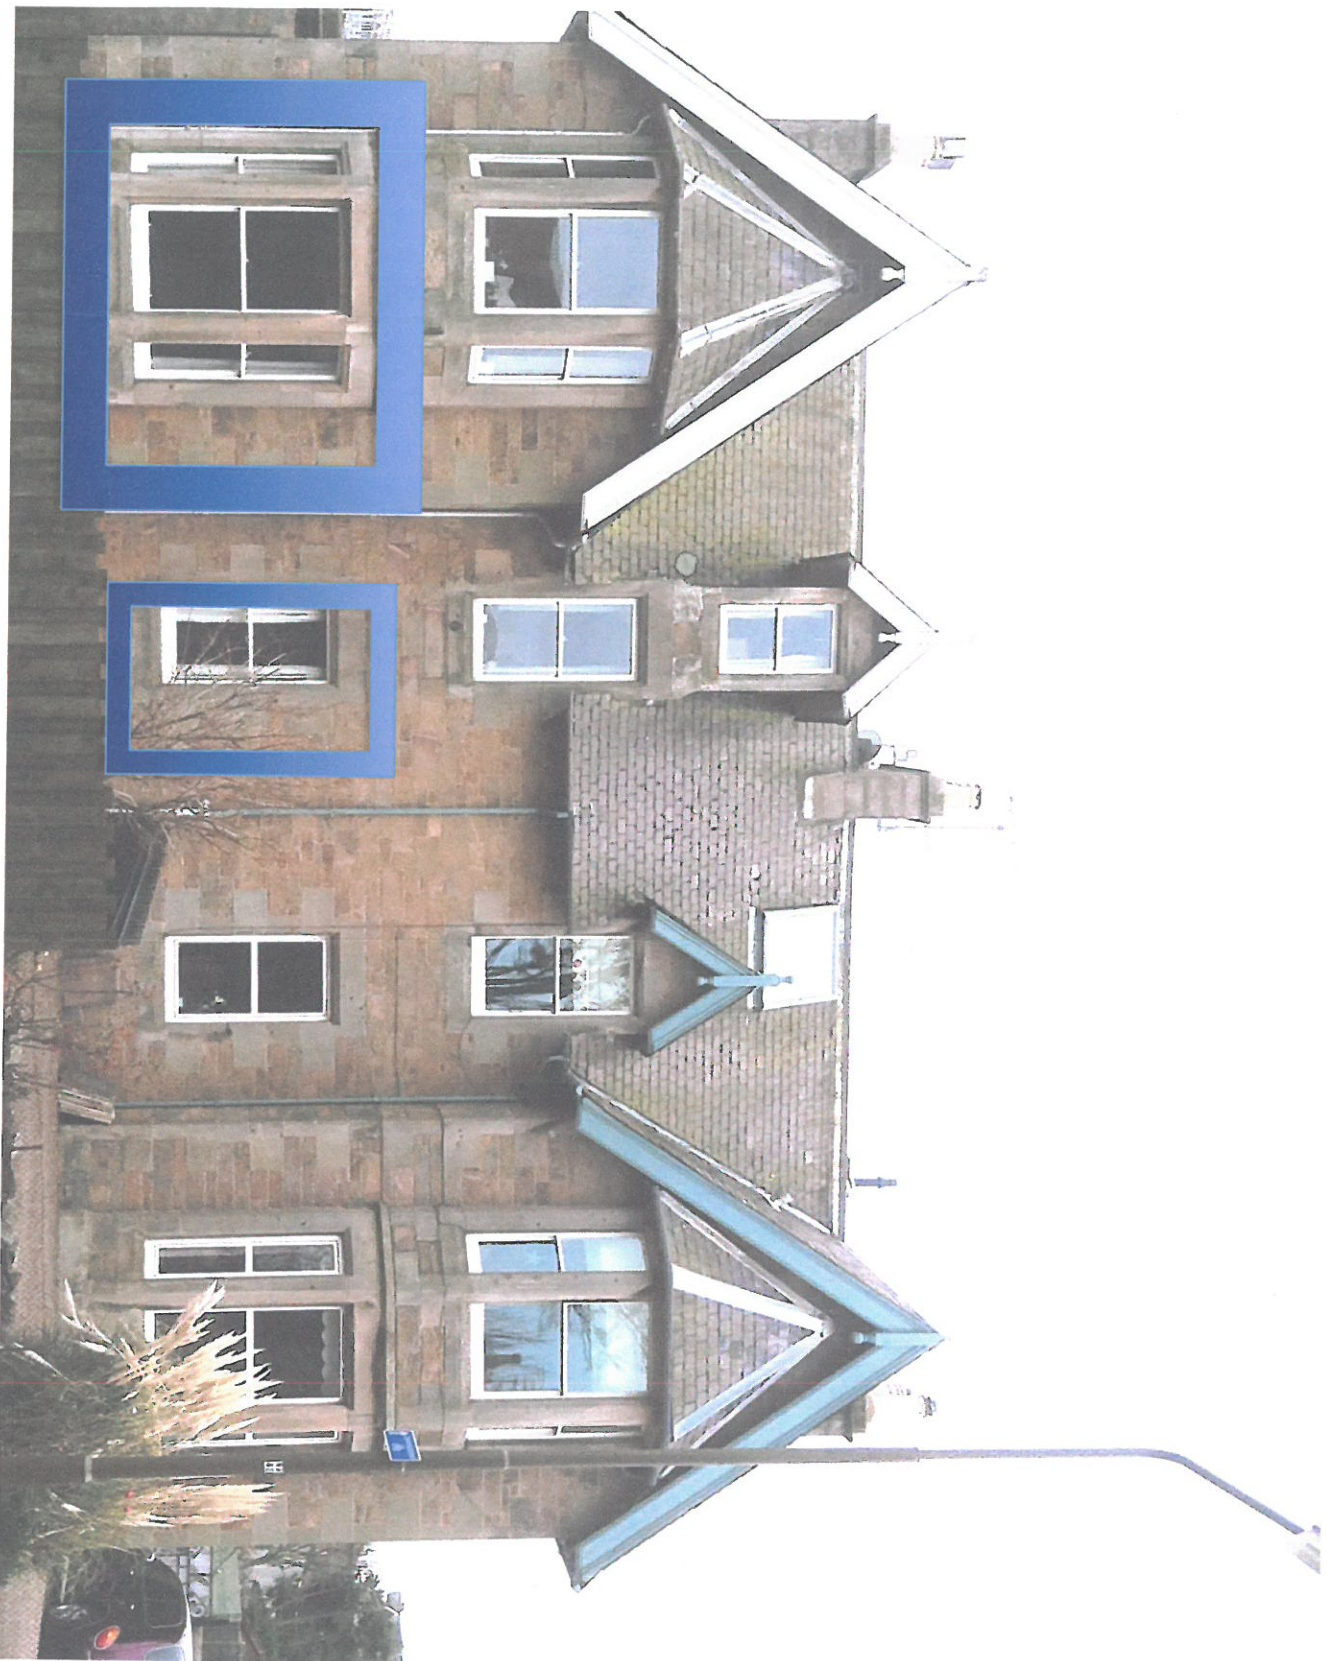
Existing white Timber Sash and Case Windows (hatched areas) to be removed and replaced with new white PVC Casement windows. Openings to be fully draught stripped and sealed to prevent air and moisture ingress. Existing lintols to remain unaffected

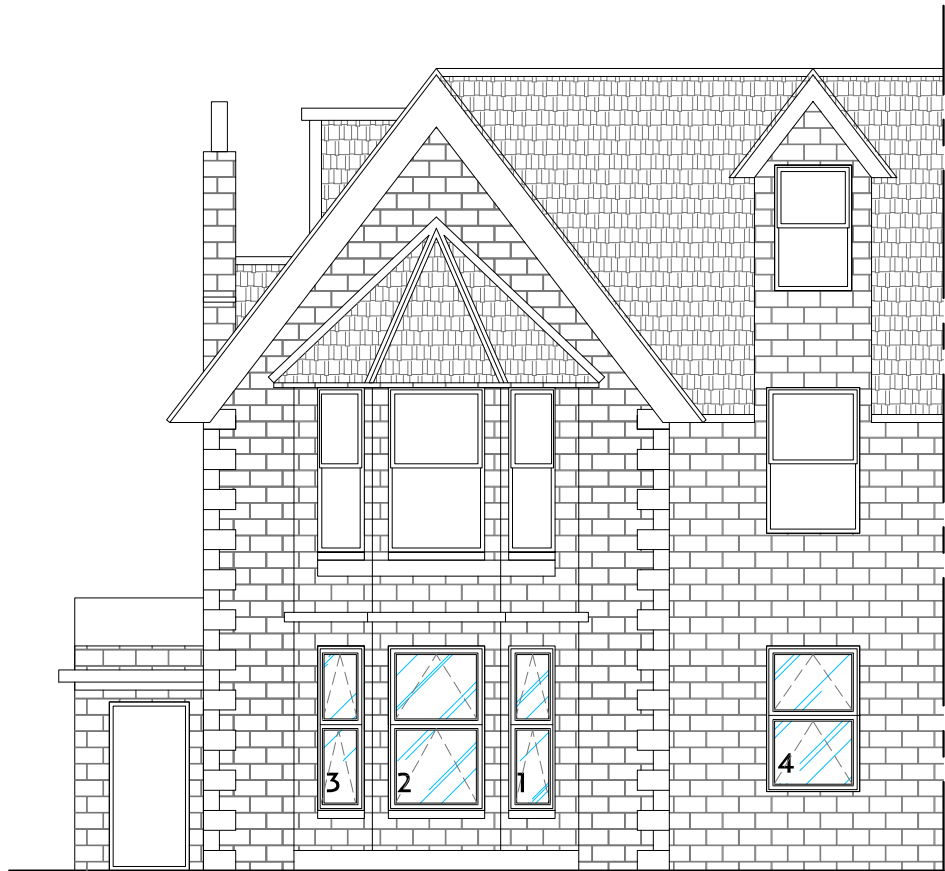
Existing North Elevation
Scale 1:100

Windows 1-3 to have bottom pane laminated.
all windows fitted with trickle vents to heads.
Window 6 is fixed
